**ENVIRONMENTAL INCIDENT REPORT  
SPILL DPTS-22  
DAKOTA PLAINS HOLDINGS INC., FACILITY**

**New Town, North Dakota**

**January 20, 2014**

**SUPPLEMENTAL ENVIRONMENTAL INCIDENT REPORT  
SPILL DPTS-22  
DAKOTA PLAINS HOLDINGS INC., FACILITY**

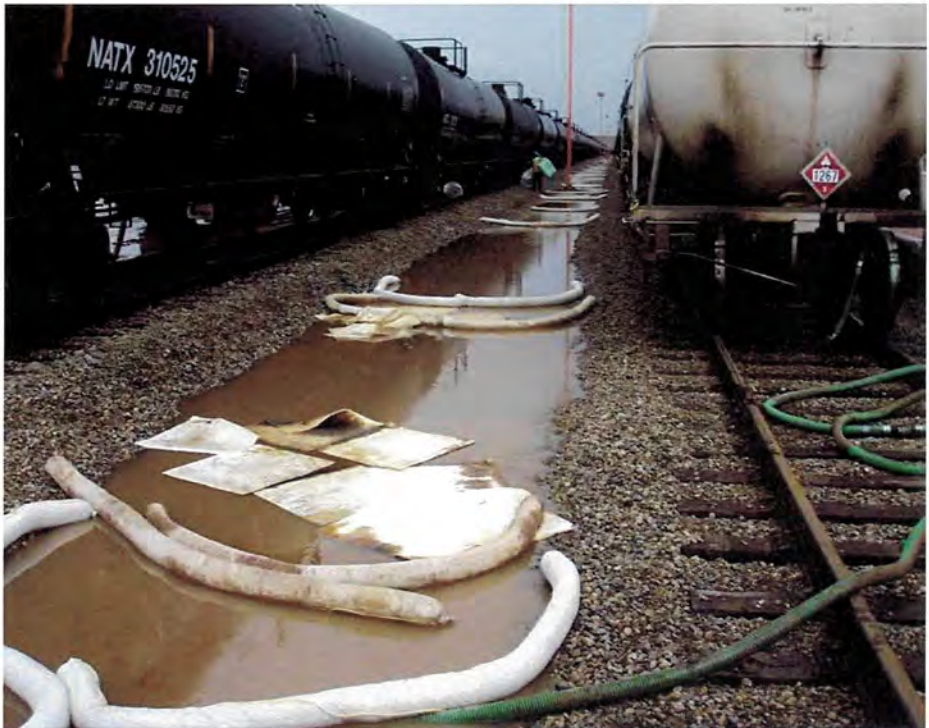
<b>Photo No.</b> 2	<b>Date</b> May 5, 2012

<b>Direction Photo Taken:</b> East		
<b>Description:</b> Trench area between Tracks 3 and 4 with oil booms and adsorbent pads.

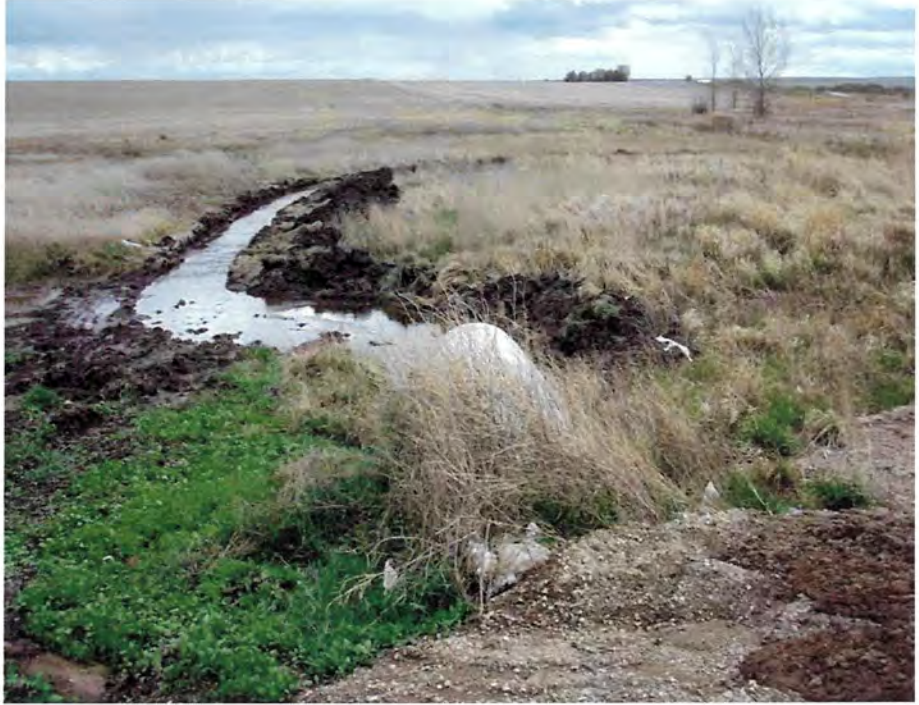
<b>Client Name:</b> Dakota Plains Holdings, Inc.		<b>Site Location:</b> Dakota Plains Holdings, Inc. Mountrail County, New Town, North Dakota	<b>Project No.</b> 38702476.00001
<b>Photo No.</b> 3	<b>Date</b> May 5, 2012

<b>Direction Photo Taken:</b> South			
<b>Description:</b> Culvert and southeastern grassy area diversion bypass trench around the spill flowage area that is located beyond the west edge of picture.

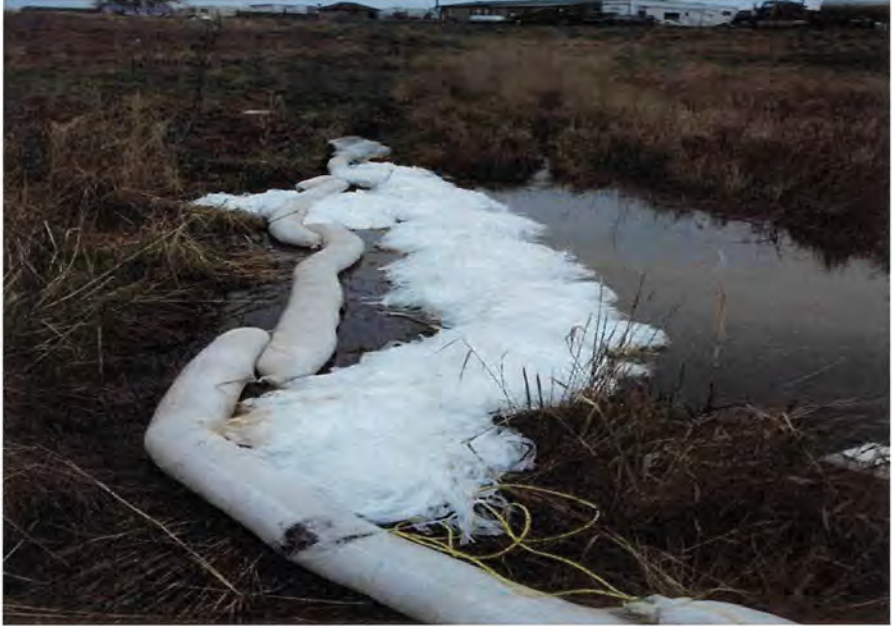
<b>Client Name:</b> Dakota Plains Holdings, Inc.		<b>Site Location:</b> Dakota Plains Holdings, Inc. Mountrail County, New Town, North Dakota	<b>Project No.</b> 38702476.00001
<b>Photo No.</b> 5	<b>Date</b> May 5, 2012

<b>Direction Photo Taken:</b> South			
<b>Description:</b> Storm water flowage to grassy area with booms and plastic adsorbent.			
<b>Photo No.</b> 6	<b>Date</b> May 5, 2012

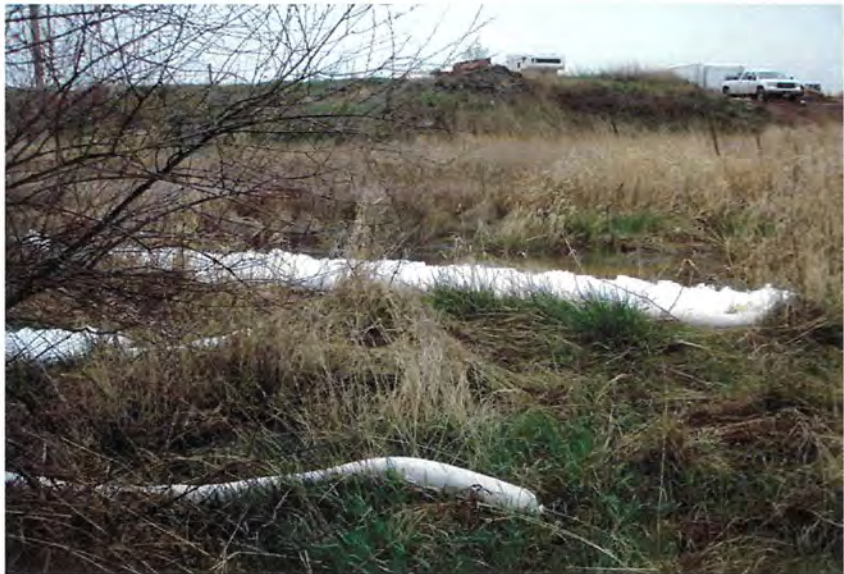
<b>Direction Photo Taken:</b> North			
<b>Description:</b> Storm water flowage in grassy area with booms and plastic adsorbent.

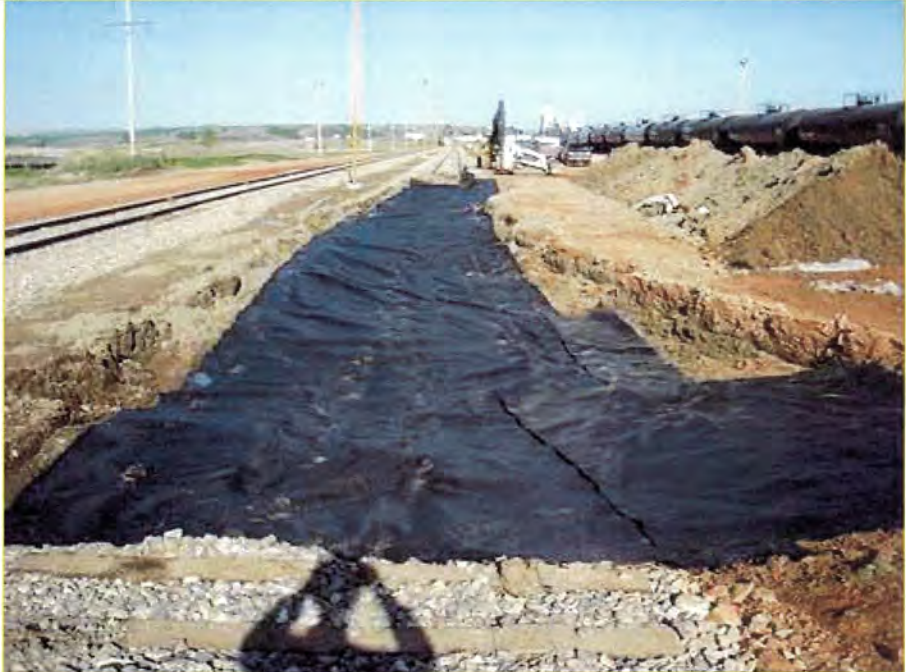
<b>Client Name:</b> Dakota Plains Holdings, Inc.		<b>Site Location:</b> Dakota Plains Holdings, Inc. Mountrail County, New Town, North Dakota	<b>Project No.</b> 38702476.00001
<b>Photo No.</b> 11	<b>Date</b> May 31, 2012

<b>Direction Photo Taken:</b> West			
<b>Description:</b> Placement of geofabric in excavation area of track bed and road base of DPTS-22.

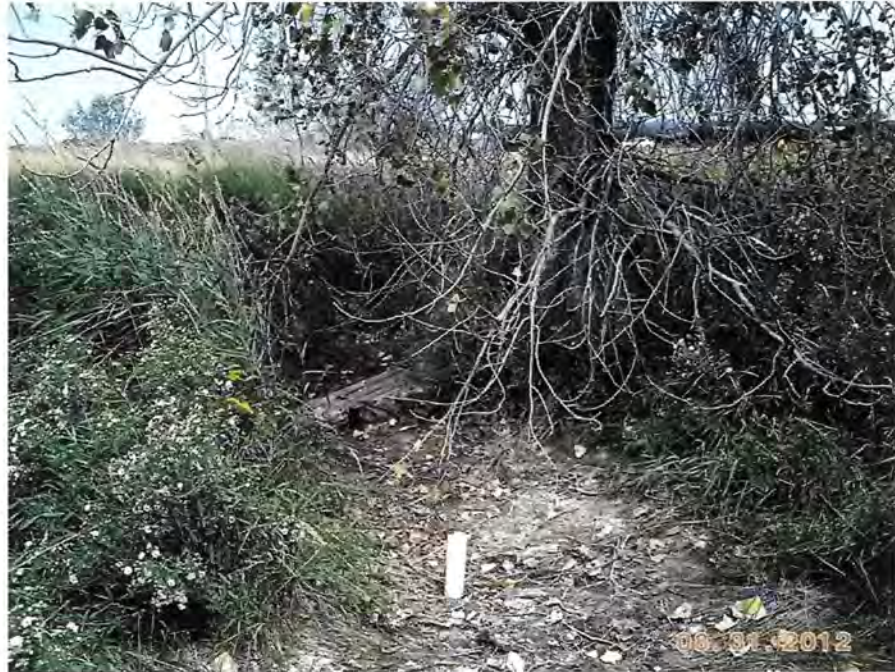
**Photo  
No.**  
13

Grassy area for sampling  
location DPTS-22-3. This  
was also the location that  
less than a yard of soil was  
excavated and then re-  
sampled as DPTS-22-OFF.

The soil samples collected from the south grassy area were also not detected above action levels for all analyses except for DPTS-22-3 (**Table 4**). Additional excavation was completed at this location and area resampled on September 14, 2012 (DPTS-22-OFF). The resample was below action levels; therefore no further action is needed in the south grassy area.
